## Brockton Receiving Water Assessment SEP

Prepared for  
*City of Brockton,  
Massachusetts*

*Supplemental Memorandum  
December 31, 2011*

*Subject: Brockton Receiving Water Assessment SEP  
Response to MassDEP Comments dated September 8, 2011*

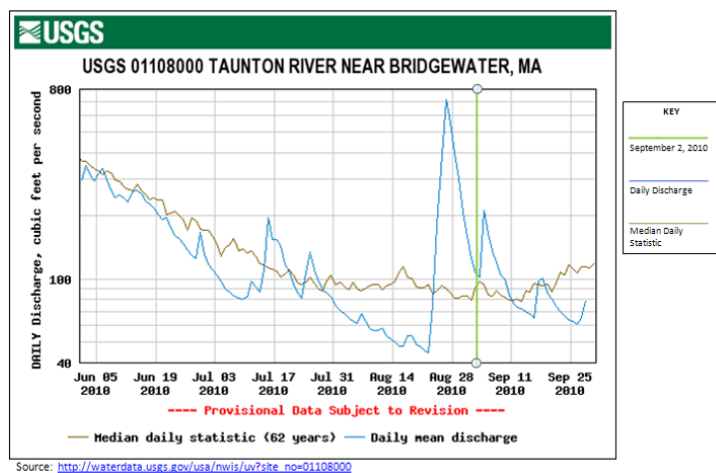
**Figure 2. USGS Daily Mean and Median Streamflow Discharge, June 1 – September 30, 2010, USGS Gage #01108000,**

Sampling was targeted for August low-flow conditions. In preparation for sampling, the CDM Project Team collected precipitation and streamflow data reported by the National Oceanographic and ([www.erh.noaa.gov](http://www.erh.noaa.gov)) and USGS streamflow monitoring gage #01108000 Taunton River for the period of ten days prior to sampling. The target streamflow value for low-flow conditions, August median flow at Taunton River gage #01108000, was determined to be 92 cfs or less, as described in the project SAP.

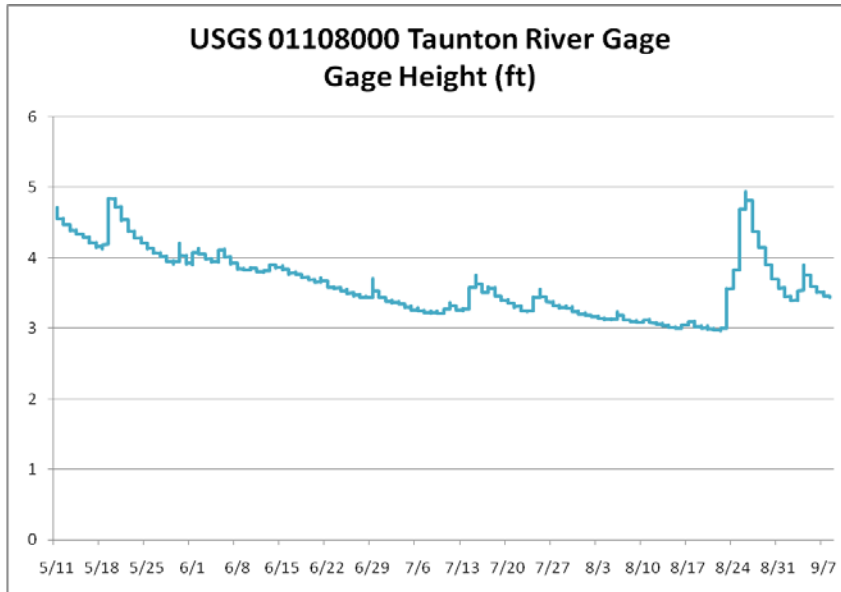
**Figure 3. USGS Daily Mean Streamflow Gage Height, May 11 – September 7, 2010, USGS Gage #01108000, Taunton River near Bridgewater, MA**

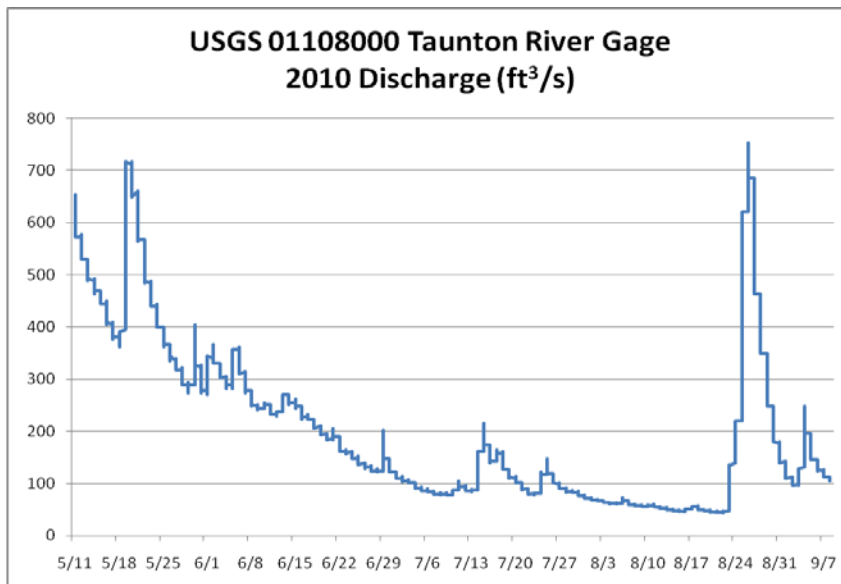
**Figure 4. USGS Mean Streamflow Daily Discharge, May 11 – September 7, 2010, USGS Gage #01108000, Taunton River near Bridgewater, MA**

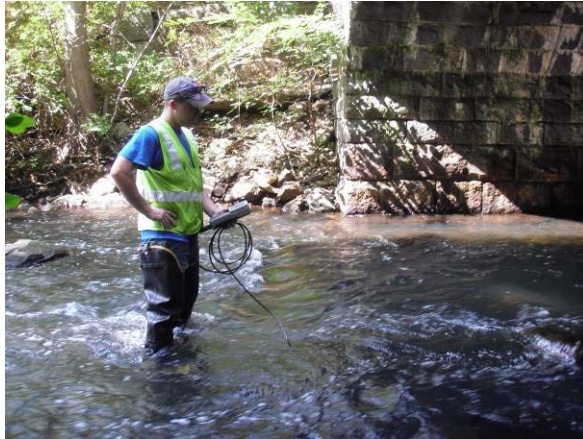
**Figure 5. S. Carey monitoring field parameters with a YSI unit at Sample Location #5, 9/02/2010**

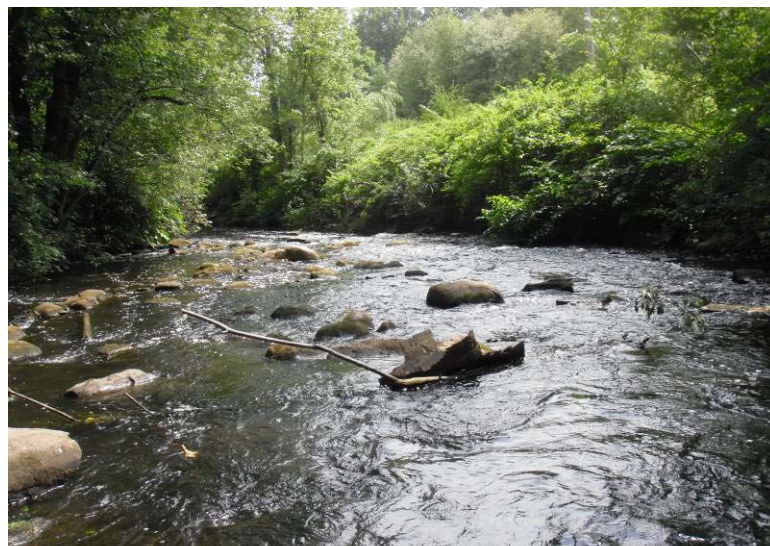
**Figure 6. Matfield River Streamflow at Sample Location #5 during Sample Location Siting, August 4, 2010**
